DEPARTMENT OF TRANSPORTATION**DIVISION OF ENGINEERING SERVICES**

Quality Assurance and Source Inspection

Contract #: 04-0120F4Cty: SF/ALA Rte: 80 PM: 13.2/13.9File #: 1.28**WELDING INSPECTION REPORT****Resident Engineer:** Casey, William**Address:** 333 Burma Road**City:** Oakland, CA 94607**Report No:** WIR-027230**Date Inspected:** 22-Feb-2012**Project Name:** SAS Superstructure**OSM Arrival Time:** 700**Prime Contractor:** American Bridge/Fluor Enterprises, a JV**OSM Departure Time:** 1730**Contractor:** American Bridge/Fluor Enterprises, a JV**Location:** Job Site**CWI Name:** Steve Jensen**CWI Present:** Yes No**Inspected CWI report:** Yes No N/A**Rod Oven in Use:** Yes No N/A**Electrode to specification:** Yes No N/A**Weld Procedures Followed:** Yes No N/A**Qualified Welders:** Yes No N/A**Verified Joint Fit-up:** Yes No N/A**Approved Drawings:** Yes No N/A**Approved WPS:** Yes No N/A**Delayed / Cancelled:** Yes No N/A**Bridge No:** 34-0006**Component:** SAS OBG**Summary of Items Observed:**

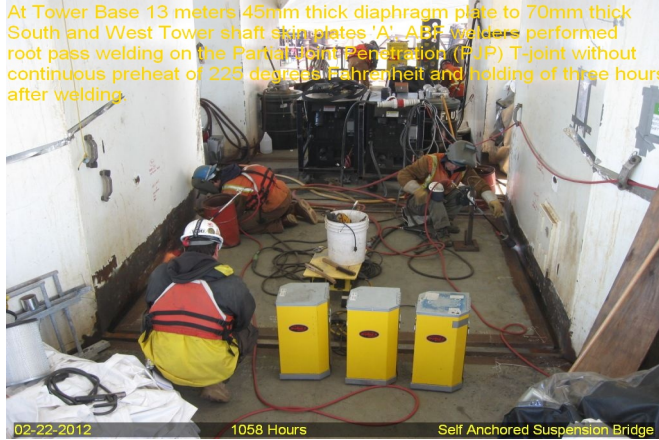
02-22-2012 1058 Hours Self Anchored Suspension Bridge

At Tower Base 13 meters 45mm thick diaphragm plate to 70mm thick South and West Tower shaft skin plates 'A'. ABF welders performed root pass welding on the Partial Joint Penetration (PJP) T-joint without continuous preheat of 225 degrees Fahrenheit and holding of three hours after welding.

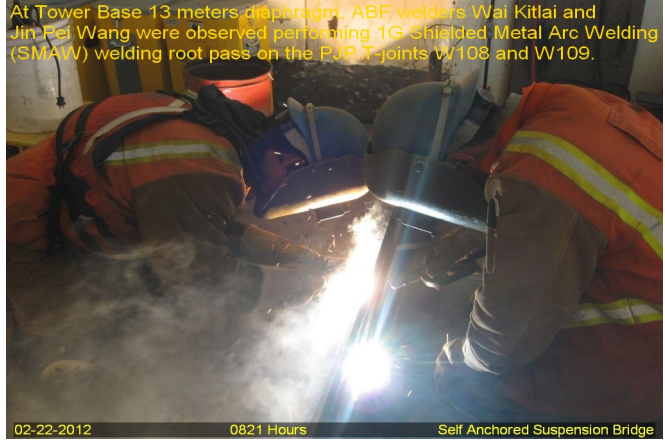
02-22-2012 0821 Hours Self Anchored Suspension Bridge

At Tower Base 13 meters diaphragm weld joint number W109, ABF welder Jin Pei Wang was observed continuing to perform 1G Shielded Metal Arc Welding (SMAW) welding root pass on the 45mm thick outer West diaphragm plate to 60mm shear plate Partial Joint Penetration (PJP) T-joint. The 45mm diaphragm has a 45 degrees bevel with an average root opening of 3.125mm with partial backing bar. The alignment for weld number W109 was -8.5mm minimum to -12mm maximum. This misalignment which was previously brought to the attention of the ABF QC, and a remedial solution has been put forward by QC through Mr. Jim Bowers and awaiting approval according to QC. The welder was noted using 3/16" diameter E7018H4R implementing Welding Procedure Specification (WPS) ABF-WPS-D15-1050A with measured working current of 228 amps. Prior welding, the welder has preheated the plates to required preheat temperature of more than 150 degrees Fahrenheit using a propylene gas torch. During welding, ABF QC Steve Jensen was noted monitoring the welder. During the shift, root pass SMAW welding on the T-joint mentioned above was completed.

At Tower Base 13 meters diaphragm weld joint number W108, ABF welder Wai Kitlai was observed continuing to perform 1G Shielded Metal Arc Welding (SMAW) welding root pass on the 45mm thick inner West diaphragm plate to 60mm shear plate PJP T-joint. The 45mm diaphragm has a 45 degrees bevel with an average root opening of 12mm, with backing bar. The alignment for weld number W108 was noted -5mm minimum to +11.5mm maximum. This misalignment which was previously brought to the attention of the ABF QC, and a remedial solution has been put forward by QC through Mr. Jim Bowers and awaiting approval according to QC. The welder was noted using 3/16" diameter E7018H4R implementing Welding Procedure Specification (WPS) ABF-WPS-D15-1050A with measured working current of 230 amps. Prior welding, the welder has preheated the plates to required preheat temperature of more than 150 degrees Fahrenheit using a propylene gas torch. During welding, ABF QC Steve Jensen was noted monitoring the welder. During the shift, root pass SMAW welding on the T-joint mentioned above was completed.

At Tower Base 13 meters diaphragm, ABF welders Wai Kitlai and Jin Pei Wang were observed performing 1G Shielded Metal Arc Welding (SMAW) welding root pass on the PJP T-joints W108 and W109.

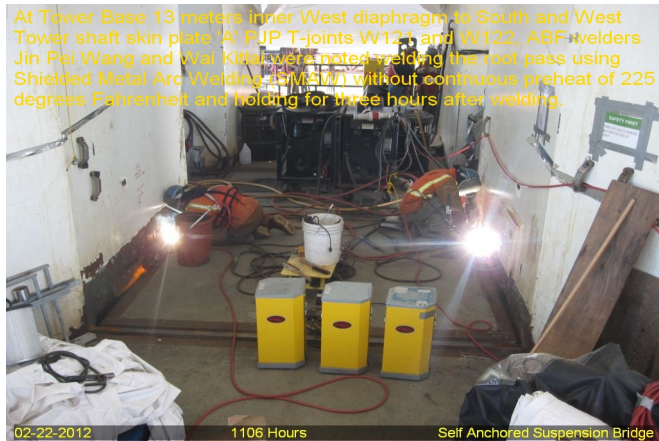
02-22-2012 1106 Hours Self Anchored Suspension Bridge

After the completion of W109, the welder has moved to PJP T-joint W121 between the 45mm thick inner West diaphragm and 70mm thick South Tower Shaft skin plate 'A'. The 45mm diaphragm has a 45 degrees bevel with an average root opening of 3.35mm without backing bar. The welder has preheated the weld joint to the required 225 degrees Fahrenheit using the propylene gas torch but did not use the heater blower to maintain the preheat as required. This was brought to the attention of ABF QC Steve Jensen who also talked and asked the ABF

Superintendent Dan Ieraci to comply with the requirements. Mr. Ieraci informed QC that ABF QC Manager Jim Bowers instruction was to use the propylene gas torch to preheat without the need to maintain and perform the post weld heat treatment. The welder performed and completed the root pass welding using the same process and procedure mentioned above. There was no post weld heat treatment or holding of the required preheat to three more hours performed on the weld joint after welding. Due to this infraction, an incident report was generated. The welder has also started the root pass at weld joint location (W128) between the 45mm thick North diaphragm plate to North Tower shaft skin plate 'E' but was not completed at the end of the shift.

After the completion of W108, the welder has moved to PJP T-joint W122 between the 45mm thick inner West diaphragm and 70mm thick West Tower Shaft skin plate 'A'. The 45mm diaphragm has a 45 degrees bevel with an average root opening of 6.4mm without backing bar. The welder has preheated the weld joint to the required 225 degrees Fahrenheit using the propylene gas torch but did not use the heater blanker to maintain the preheat as required. The welder performed and completed the root pass welding using the same process and procedure mentioned above. There was no post weld heat treatment or holding of the required preheat to three more hours performed on the weld joint after welding. Same infraction was noted and it was included in the incident report that was generated. The welder has also started the root pass at weld joint location (W127) between the 45mm thick North diaphragm plate to West Tower shaft skin plate 'E' but was not completed at the end of the shift.

At Tower Base 13 meters inner West diaphragm to South and West Tower shaft skin plate 'A' PJP T-joints W121 and W122, ABF welders Jin Pei Wang and Wai Kitlai were noted welding the root pass using Shielded Metal Arc Welding (SMAW) without continuous preheat of 225 degrees Fahrenheit and holding for three hours after welding.

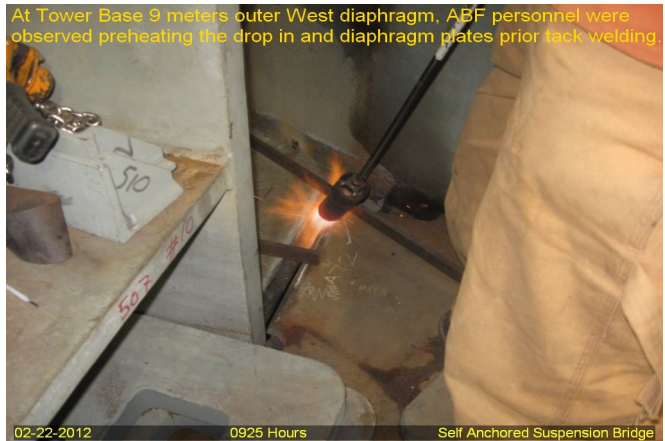
02-22-2012 0925 Hours Self Anchored Suspension Bridge

At Tower Base 9 meters diaphragm, fit up/tack welding of drop in plates at outer West diaphragm was noted continuing. ABF welder Luo Xiao Hua was observed performing tack welding the 45mm drop ins to 60mm thick shear plate using Shielded Metal Arc Welding (SMAW) with 1/8" diameter E7018H4R electrode. The plates were preheated to required temperature of 150 degrees Fahrenheit using propylene gas torch prior welding. During the tack welding, ABF QC Steve Jensen was noted monitoring the parameters of the welder. At the end of the shift, fit up/tack welding of two more drop ins for the outer West diaphragm was completed.

At Tower Base 9 meters outer West diaphragm, ABF personnel were observed preheating the drop in and diaphragm plates prior tack welding.
